Clarke Caton Hintz

An Update to the “Capital Master Plan for the Hoboken Public Library”

Submitted to:
The Trustees of the Hoboken Public Library

November 20, 2019

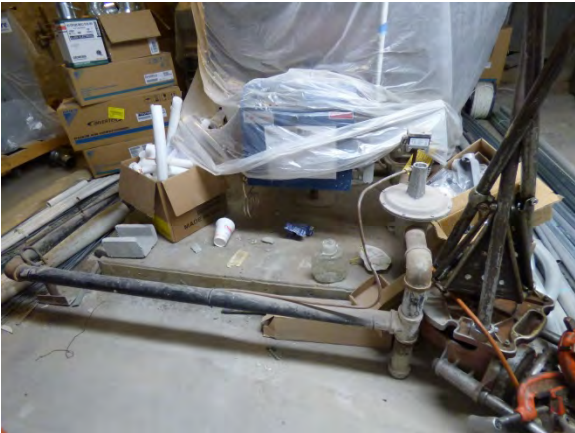
Photo H-1

The building is primarily heated by perimeter cast iron radiators (CIR) utilizing low pressure steam. Steam is generated by a HB Smith 350 mils boiler (see Photos H-1, H-2, H-3) with a natural gas input of 2,009,000 btu/hr and a net IBR output of 1,211,700 btu/hr. The boiler is located in the Basement at the southwest corner of the building. It appears to be in good physical condition. The associated low pressure steam (LPS) and low pressure condensate/return (LPR) piping appear to be much older than the boiler. Most of the LPS and LPR piping throughout the building are exposed and are not insulated. The steam heating system has no zoning controls. The building is primarily cooled by split type and indoor packaged air conditioning units. The building has no mechanical ventilation system. The building has operable windows for natural ventilation.

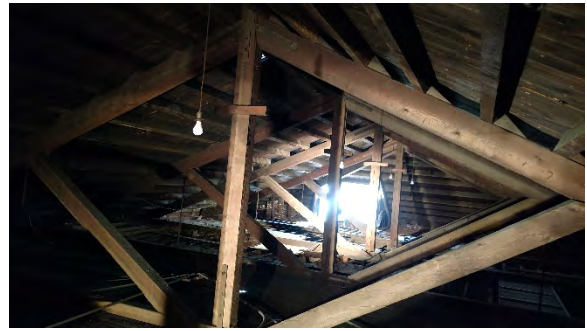
The roof trusses were assessed to see if they could support occupancy of the attic for reading rooms, meeting rooms and other Library functions. It was found that the trusses adequately support the roof loads and the ceiling over the third floor, but that they could not support occupancy of the attic without significant additional reinforcement.

Photo S-1: Existing roof trusses visible in the attic.

1. The movement of the second stair at the north wall is still apparent. The proposed repair to this stair should happen in the near future.
2. When work is done in the attic, either to install new HVAC units or to create additional program space, the repairs to the roof trusses should be completed.

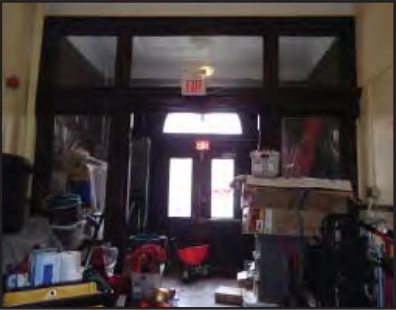
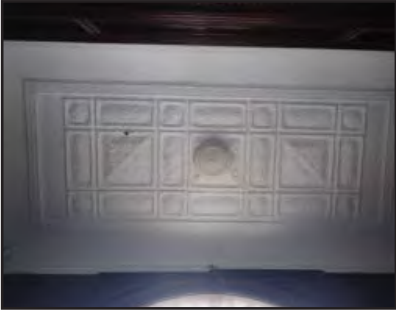
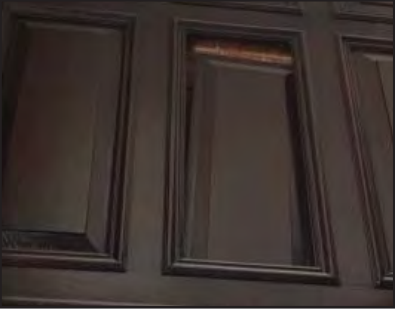
<div><div>Room Number: 108Room Name: Park Avenue Entrance VestibuleRecommendation:Priority:</div><div>Significance of Space: Primary</div><div>Floor: Polychromatic terrazzo flooring with Grecian meander border in good condition.3</div><div>Walls: Wood paneled full-height wainscot in good condition except for one panel at south wall that has become unfastened and slipped.2</div><div>Ceiling: Painted patterned tin ceiling in good condition.2</div><div>Architectural Features: Highly decorative wood paneling.2</div><div>Lighting: Contemporary surface-mounted fixture is not historically appropriate.2</div><div>Openings: Wood doors with glass inserts and semi-circle transom window with decorative exterior scrollwork are in good condition. Contemporary doorhardware is not historically sensitive.2</div></div>				<div>

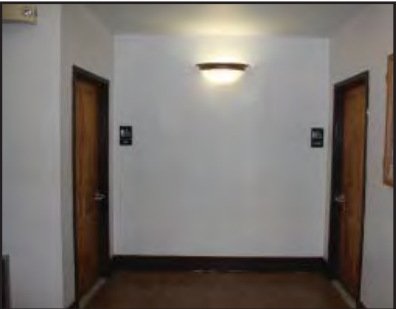
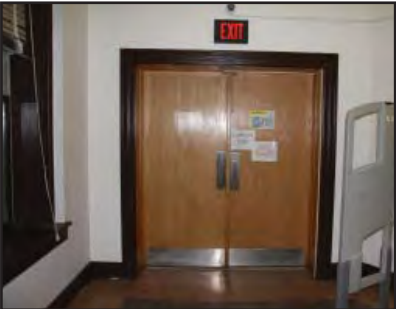
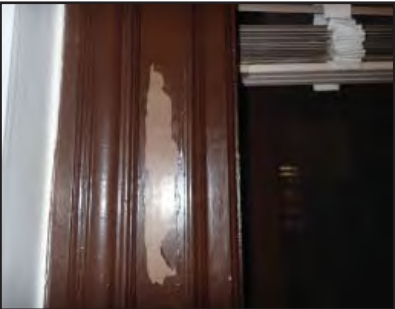
<div><div>Room Number: 110Room Name: First Floor Elevator HallRecommendation:Priority:</div><div>Significance of Space: Not significant</div><div>Floor: Contemporary terrazzo flooring.3</div><div>Walls: Painted gypsum wall board (GWB) in good condition.3</div><div>Ceiling: Painted GWB in good condition.3</div><div>Architectural Features:3</div><div>Lighting: Contemporary wall sconce.3</div><div>Openings: Original wood window trim in good condition with one area of delaminating paint. The historic wood door frame remains, but a contemporary frame and double door has been installed within leading to Hall 109.3</div></div>				<div>

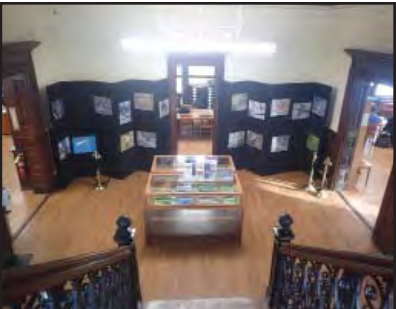
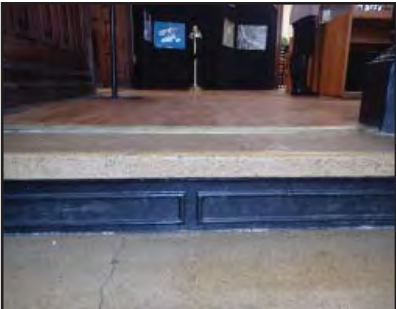
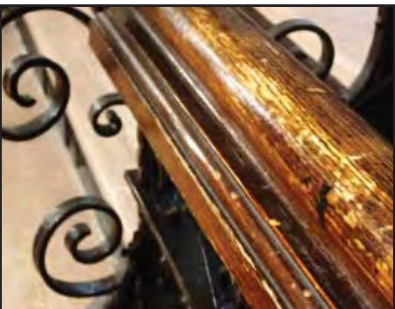
</div>			
<div><div>Room Number: 200Room Name: Second Floor Circulation HallRecommendation:Priority:</div><div>Significance of Space: Most significant</div><div>Floor: Contemporary synthetic wood floor in good condition. The transition from the historic stairs to the contemporary flooring is a tripping hazard.1</div><div>Walls: Plaster above wood paneled wainscoting in good condition.1</div><div>Ceiling: Plaster with decorative wood coffers and crown moulding.1</div><div>Architectural Features: Plaster corbels and pilasters in good condition, and central staircase railing in good condition with worn wood handrails. The lowest tread of the stair is damaged and missing at the north side.1</div><div>Lighting: Contemporary fluorescent light and suspended track light; neither are historically sensitive.1</div><div>Openings: Original decorative wood door frames in good condition except for some areas of wear on the finish. The original doors had been previously removed.1</div><div>Notes: Surface-mounted wiremold and miscellaneous wires run along chair rail and around door frames.</div></div>				<div>

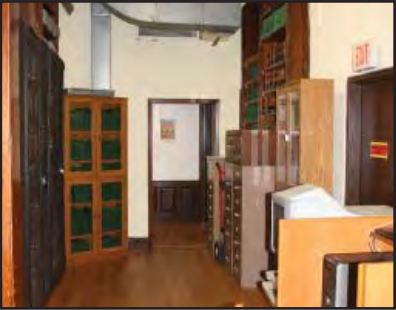
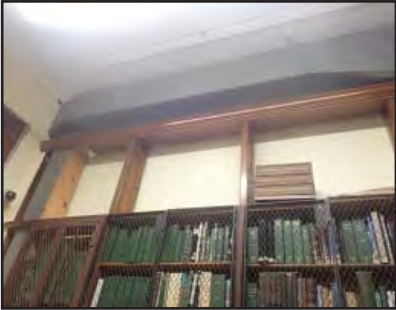
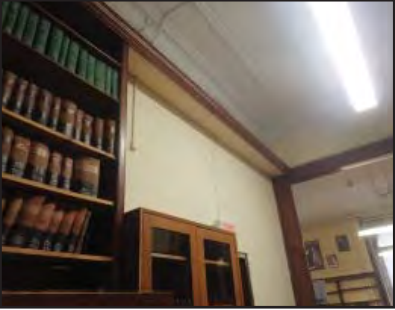
<div>Room Number: 205</div> <div>Room Name: Book Stacks</div> <div>Significance of Space: Primary</div> <div>Floor: Contemporary synthetic wood flooring in good condition.</div> <div>Walls: Plaster in good condition. An opening was over cut at the west wall for duct.</div> <div>Ceiling: Painted patterned tin ceiling in good condition except for some paint delamination.</div> <div>Architectural Features: Built-in bookcases. Remaining cases are in fair condition, but large portions of shelving had been previously removed. Duct work occupies part of the vacant bookcases.</div> <div>Lighting: Contemporary fluorescent light, not historically sensitive.</div> <div>Openings: Original wood frames from Rooms 204 and 206 are in fair condition. Contemporary hollow metal frame and door leads to Stair 2.</div> <div>Notes: Large scale duct work is exposed at south and west walls.</div>	<div>Recommendation:</div> <div>Remove contemporary flooring and two layers of VAT below. Repair and refinish original flooring.</div> <div>Prep, repair and repaint per finish analysis.</div> <div>Reconfigure HVAC to be less obtrusive.</div> <div>Strip paint and repaint per finish analysis.</div> <div>Repair and refinish per finish analysis.</div> <div>Replace with appropriate LED fixtures.</div> <div>Touch up stain and refinish per paint analysis.</div> <div>Install historically appropriate door and frame.</div> <div>Reconfigure HVAC and restrooms to be less obtrusive.</div>	<div>Priority:</div> <div>2</div> <div>2</div> <div>2</div> <div>2</div> <div>2</div> <div>2</div> <div>2</div> <div>2</div> <div>2</div>

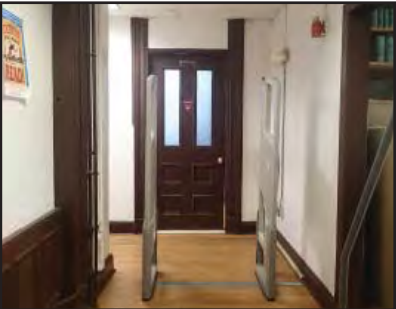
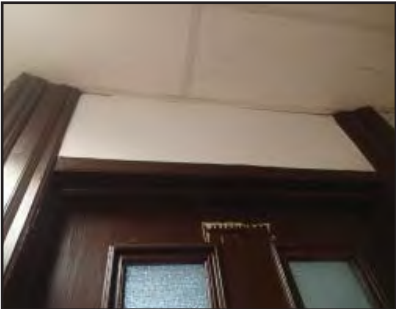
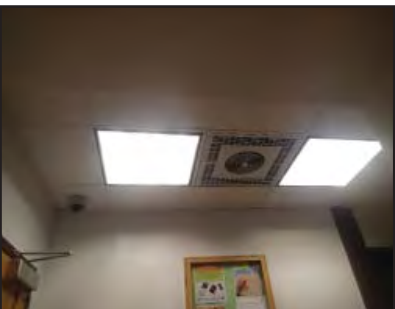
<div>Room Number: 206</div> <div>Room Name: Second Floor Elevator Hall</div> <div>Significance of Space: Secondary; reconfigured for elevator, but has original details, etc.</div> <div>Floor: Contemporary synthetic wood floor in good condition.</div> <div>Walls: Painted plaster and GWB in good condition.</div> <div>Ceiling: 2x4 ACT ceiling in fair condition.</div> <div>Lighting: Lay-in 2x2 lights.</div> <div>Openings: Original wood trim where remaining is partially obstructed by ACT ceiling.</div>	<div>Recommendation:</div> <div>If possible, remove contemporary flooring and two layers of VAT below. Repair and refinish original flooring.</div> <div>Prep and repaint per finish analysis.</div> <div>Expose original ceiling if possible.</div> <div>Install appropriate LED fixtures.</div> <div>Expose original wood trim; touch up stain and refinish per finish analysis.</div>	<div>Priority:</div> <div>2</div> <div>2</div> <div>3</div> <div>3</div> <div>3</div>

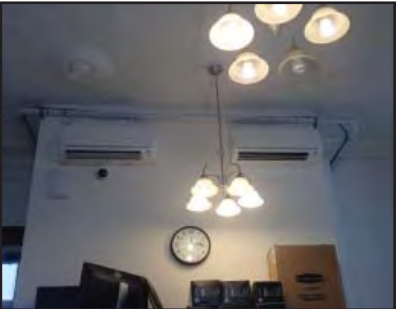
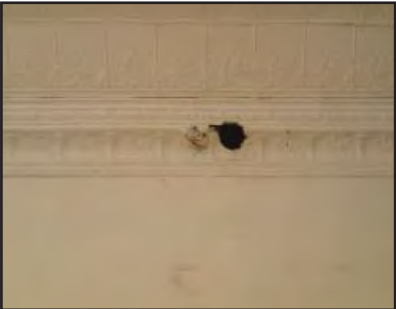
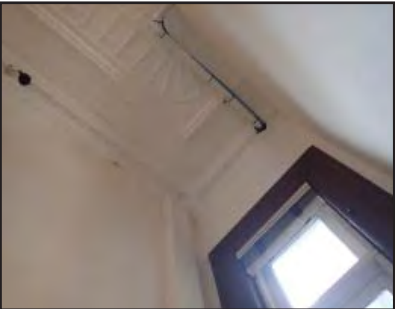
<div>Room Number: 207</div> <div>Room Name: Staff Work Room</div> <div>Significance of Space: Secondary, currently used by staff.</div> <div>Floor: Original wood floor in good condition.</div> <div>Walls: Painted wood beadboard and chair rail with plaster above in good condition.</div> <div>Ceiling: Painted patterned tin ceiling in good condition except for some holes where surface-mounted plumbing had been previously removed, and minor areas of paint delamination.</div> <div>Lighting: Contemporary lights.</div> <div>Openings: Original painted wood window trim. Contemporary wood door with hollow metal frame.</div> <div>Notes: Surface mounted wiremold, electrical conduit, and plumbing.</div>	<div>Recommendation:</div> <div>Repair and refinish as required.</div> <div>Repair and repaint as required.</div> <div>Repair and repaint as required.</div> <div></div> <div></div>	<div>Priority:</div> <div>3</div> <div>3</div> <div>3</div> <div>3</div> <div>3</div>

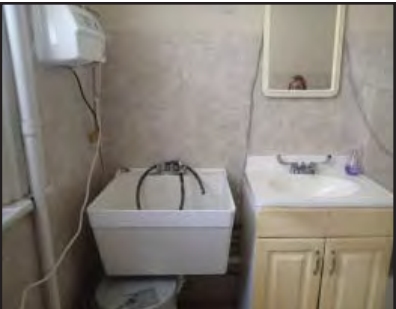
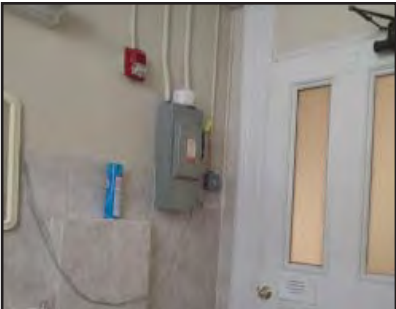
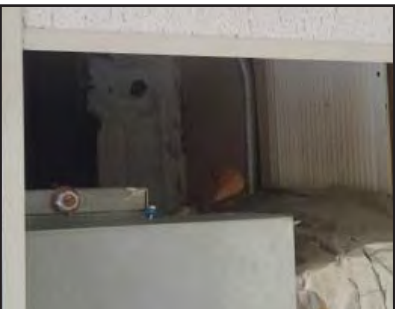
<div>Room Number: 208</div> <div>Room Name: Second Floor Restroom</div> <div>Significance of Space: Tertiary, utilitarian.</div> <div>Floor: Contemporary tile in fair condition.</div> <div>Walls: Contemporary tile in fair condition with plaster above. Plaster is damaged on east wall.</div> <div>Ceiling: 2x4 ACT ceiling considerably lower than original plaster ceiling. Not historically sensitive, but in fair condition. Original plaster ceiling with decorative mouldings still exist in addition to duct work above.</div> <div>Lighting: Surface mounted light above sink.</div> <div>Openings: Original wood door with transom and trim, and window trim are intact, but bisected by ACT ceiling. Door transom has been blocked.</div> <div>Notes: Surface-mounted electrical conduit. Electrical cords loosely strung to outlet. A janitor sink is adjacent to contemporary bathroom sink and vanity cabinet.</div>	<div>Recommendation:</div> <div>Expose original ceiling where possible.</div> <div>Install new, appropriate LED fixtures.</div> <div>Expose original door and transom if possible.</div>	<div>Priority:</div> <div>3</div> <div>3</div> <div>3</div> <div>3</div> <div>3</div>

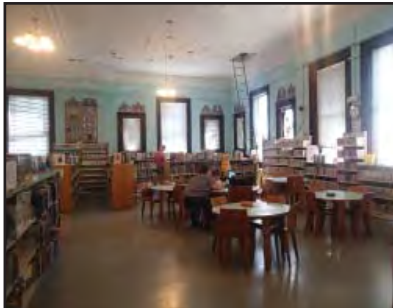
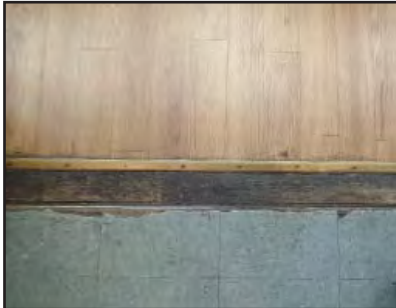
<div>Room Number: 300</div> <div>Room Name: Children's Room</div> <div>Recommendation:</div> <div>Priority:</div>				
<div>Significance of Space: Primary; most significant public space</div> <div>Floor: Vinyl tile in poor condition with chipped edges, cracks, and tripping hazard at the top of the stairs.</div> <div>Walls: Plaster in fair condition. Decorative crown mouldings have had previous repairs, but do not match the existing design or texture.</div> <div>Ceiling: Painted patterned tin ceiling. Substrate appears to be in good condition but the paint is delaminating.</div> <div>Architectural Features: Cabinets with original hardware at north & east sides with some minor wear of finish. Decorative railing at stair in fair condition.</div> <div>Lighting: Contemporary lights.</div> <div>Openings: Ornate door and window trim intact and in fair condition. Attic access does not have an operational door, and the ladder appears unsafe and is accessible to the public.</div> <div>Notes: Large exposed HVAC equipment and duct work. Insufficient single restroom.</div>		<div>Remove vinyl tile and two layers of VAT below.</div> <div>Repair and refinish original flooring.</div> <div>Prep, repair and repaint per finish analysis.</div> <div>Strip paint and repaint per finish analysis.</div> <div>Repair and refinish per finish analysis.</div> <div>Replace with appropriate LED fixtures.</div> <div>Touch up stain and refinish per paint analysis.</div> <div>Relocate attic access and ladder to less obtrusive location.</div> <div>Reconfigure HVAC & restroom to be less obtrusive. Restroom should be relocated.</div>	<div>1</div> <div>1</div> <div>1</div> <div>1</div> <div>1</div> <div>1</div> <div>1</div> <div>1</div>	<div>

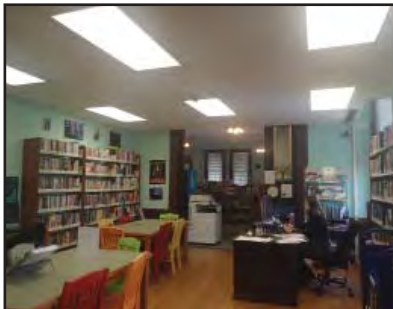
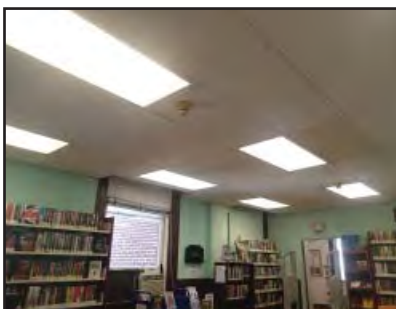
<div>Room Number: 301</div> <div>Room Name: Young Adult Room</div> <div>Recommendation:</div> <div>Priority:</div>		<div>Remove contemporary flooringand two layers of VAT below. Repair and refinish original flooring.</div> <div>Prep and repaint/ refinish per paint analysis.</div> <div>Install new chair rail to match original.</div> <div>Reconfigure HVAC to allow original ceiling to be exposed.</div> <div>Touch up stain and refinish per paint analysis</div> <div>Replace with appropriate LED fixtures</div> <div>Repair and repaint per paint analysis</div>	<div>1</div> <div>1</div> <div>1</div> <div>1</div> <div>1</div> <div>1</div> <div>1</div>	<div>

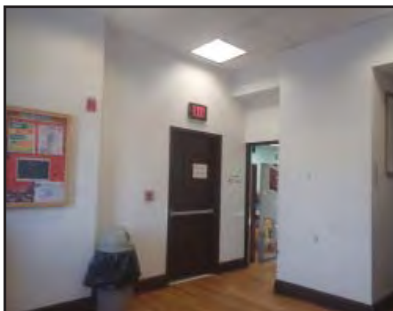
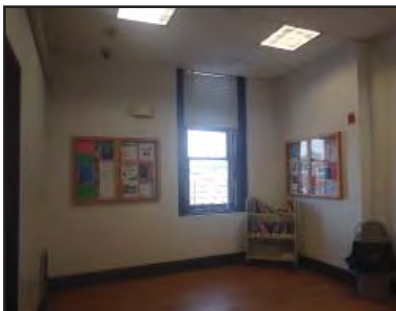
</div>
<div>Room Number: 302</div> <div>Room Name: Third Floor Elevator Hall</div> <div>Recommendation:</div> <div>Priority:</div>		<div>Consider reconfiguring the ceiling to allow for the window to be fully exposed. As this is a completely reconfigured space, the design of trim and doors is more flexible. Consider trim and detailing that is more compatible with the building as a whole.</div>	<div>3</div> <div>3</div> <div>3</div>	<div>

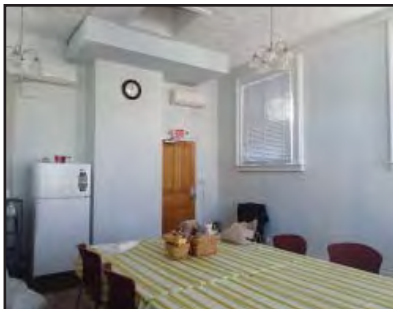
<div>Room Number: 303</div> <div>Room Name: Staff Break Room</div> <div>Recommendation:</div> <div>Priority:</div>		<div>If this becomes a public space, remove laminate flooring and two layers of VAT; repair and refinish original wood floor.</div> <div>Prep and repaint per finish analysis.</div> <div>Repaint as required.</div> <div>If this becomes a public sapce, consider installing door and trim that is more compatibel with the original features in the building.</div>	<div>3</div> <div>2</div> <div>2</div> <div>3</div> <div>3</div>	<div>
