Clarke Caton Hintz

An Update to the “Capital Master Plan for the Hoboken Public Library”

Submitted to:
The Trustees of the Hoboken Public Library

November 20, 2019

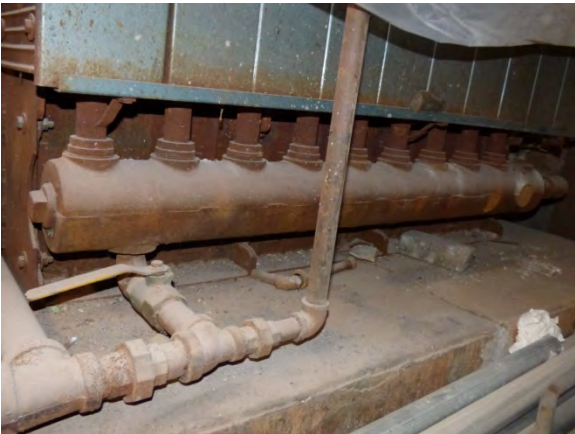
Photo H-2

The building is primarily heated by perimeter cast iron radiators (CIR) utilizing low pressure steam. Steam is generated by a HB Smith 350 mils boiler (see Photos H-1, H-2, H-3) with a natural gas input of 2,009,000 btu/hr and a net IBR output of 1,211,700 btu/hr. The boiler is located in the Basement at the southwest corner of the building. It appears to be in good physical condition. The associated low pressure steam (LPS) and low pressure condensate/return (LPR) piping appear to be much older than the boiler. Most of the LPS and LPR piping throughout the building are exposed and are not insulated. The steam heating system has no zoning controls. The building is primarily cooled by split type and indoor packaged air conditioning units. The building has no mechanical ventilation system. The building has operable windows for natural ventilation.

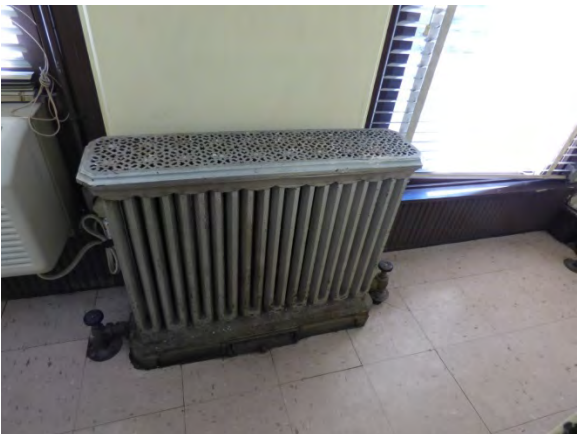
Photo H-4

The Administrative Offices on the First Floor are heated by perimeter CIR's (see Photo H-4) and floor mounted fan coil units (see Photo H-5). Window type Packaged Terminal Air Conditioning (PTAC) units (see Photo H-6) provide cooling. The CIR's utilize steam and the FCU's use hot water. Heating hot water is generated by a Utica Model MGB-200J with a

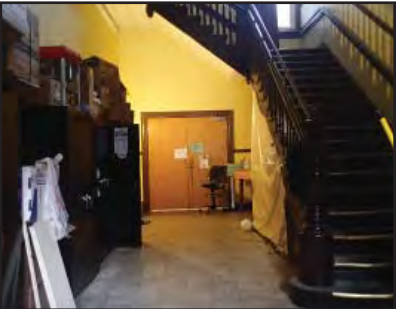
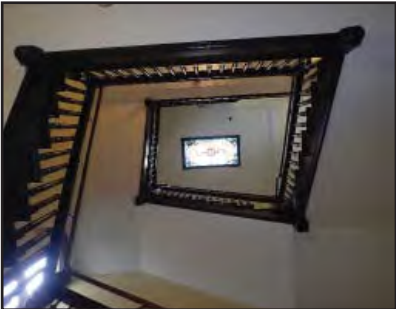
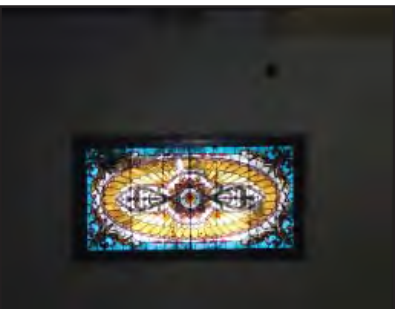
<div><div>Existing Conditions Assessment</div><div>The Hoboken Public Library</div><div>500 Park Avenue</div><div>Hoboken, NJ 07960</div><div>Block: 6003 Lot: 15</div></div>							
<div><div>Room Number: 109Room Name: Park Avenue Entrance HallRecommendation:Priority:</div><div>Significance of Space: Primary</div><div>Floor: Polychromatic terrazzo flooring with Grecian meander border in good condition.3</div><div>Walls: Plaster in good condition except for areas of cracking on north wall at stair.2</div><div>Ceiling: Plaster with plaster crown moulding in good condition.2</div><div>Architectural Features: Ornate wood staircase is in fair condition, however, it appears to be pulling away from the north wall. The existing stained glass window at the top of the stair is in need of repair and stabilization.2</div><div>Lighting: Contemporary surface-mounted fixture is not historically appropriate.2</div><div>Openings: Large scale wood framed sidelights and transom to Vestibule 108 in good condition. Original doors have been removed but are in storage.2</div><div>Notes: This hall is off-limits to the public and is currently being used as storage, but contains some of the best architectural features of the building.</div></div>				<div>

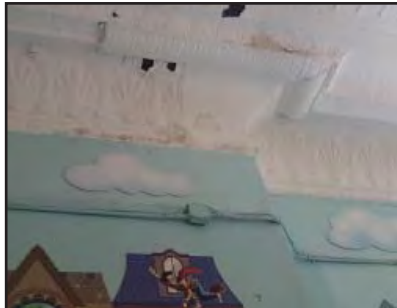
<div>Room Number: 300</div> <div>Room Name: Children's Room</div> <div>Recommendation:</div> <div>Priority:</div>				
<div>Significance of Space: Primary; most significant public space</div> <div>Floor: Vinyl tile in poor condition with chipped edges, cracks, and tripping hazard at the top of the stairs.</div> <div>Walls: Plaster in fair condition. Decorative crown mouldings have had previous repairs, but do not match the existing design or texture.</div> <div>Ceiling: Painted patterned tin ceiling. Substrate appears to be in good condition but the paint is delaminating.</div> <div>Architectural Features: Cabinets with original hardware at north & east sides with some minor wear of finish. Decorative railing at stair in fair condition.</div> <div>Lighting: Contemporary lights.</div> <div>Openings: Ornate door and window trim intact and in fair condition. Attic access does not have an operational door, and the ladder appears unsafe and is accessible to the public.</div> <div>Notes: Large exposed HVAC equipment and duct work. Insufficient single restroom.</div>		<div>Remove vinyl tile and two layers of VAT below.</div> <div>Repair and refinish original flooring.</div> <div>Prep, repair and repaint per finish analysis.</div> <div>Strip paint and repaint per finish analysis.</div> <div>Repair and refinish per finish analysis.</div> <div>Replace with appropriate LED fixtures.</div> <div>Touch up stain and refinish per paint analysis.</div> <div>Relocate attic access and ladder to less obtrusive location.</div> <div>Reconfigure HVAC & restroom to be less obtrusive. Restroom should be relocated.</div>	<div>1</div> <div>1</div> <div>1</div> <div>1</div> <div>1</div> <div>1</div> <div>1</div> <div>1</div>	<div>

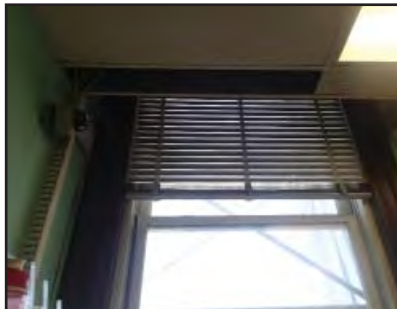
<div>Room Number: 301</div> <div>Room Name: Young Adult Room</div> <div>Recommendation:</div> <div>Priority:</div>		<div>Remove contemporary flooringand two layers of VAT below. Repair and refinish original flooring.</div> <div>Prep and repaint/ refinish per paint analysis.</div> <div>Install new chair rail to match original.</div> <div>Reconfigure HVAC to allow original ceiling to be exposed.</div> <div>Touch up stain and refinish per paint analysis</div> <div>Replace with appropriate LED fixtures</div> <div>Repair and repaint per paint analysis</div>	<div>1</div> <div>1</div> <div>1</div> <div>1</div> <div>1</div> <div>1</div> <div>1</div>	<div>

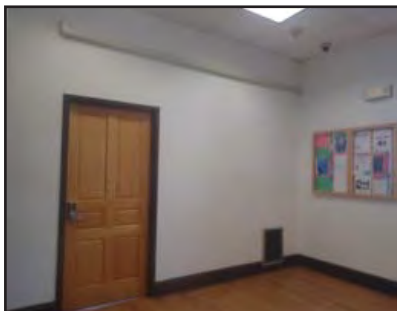
</div>
<div>Room Number: 302</div> <div>Room Name: Third Floor Elevator Hall</div> <div>Recommendation:</div> <div>Priority:</div>		<div>Consider reconfiguring the ceiling to allow for the window to be fully exposed. As this is a completely reconfigured space, the design of trim and doors is more flexible. Consider trim and detailing that is more compatible with the building as a whole.</div>	<div>3</div> <div>3</div> <div>3</div>	<div>

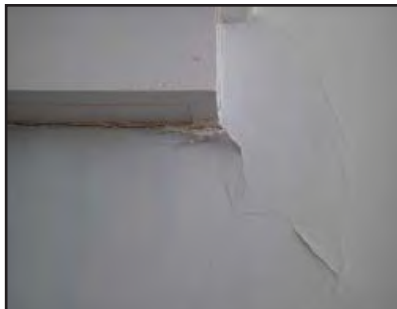
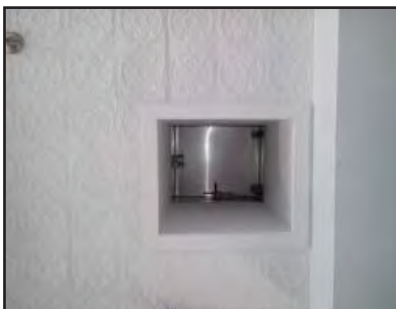
<div>Room Number: 303</div> <div>Room Name: Staff Break Room</div> <div>Recommendation:</div> <div>Priority:</div>		<div>If this becomes a public space, remove laminate flooring and two layers of VAT; repair and refinish original wood floor.</div> <div>Prep and repaint per finish analysis.</div> <div>Repaint as required.</div> <div>If this becomes a public sapce, consider installing door and trim that is more compatibel with the original features in the building.</div>	<div>3</div> <div>2</div> <div>2</div> <div>3</div> <div>3</div>	<div>
